Test Report No. TSNHG2302697701 Date: 12 Oct 2023 Page 1 of 4

Sample Name: 120Z FINE ENAMEL CUP W/BLUE LIP

Test Requested	Conclusion
Regulation (EC) No 1935/2004 of the European Parliament and of the Council of	PASS
27 October 2004 - ISO 4531:2022-Release of heavy metals

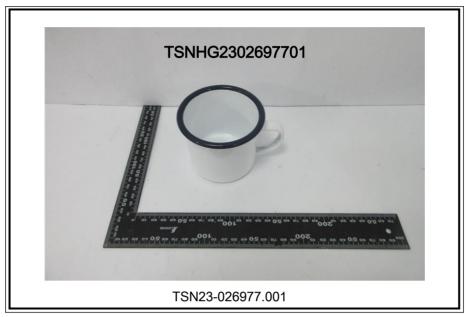
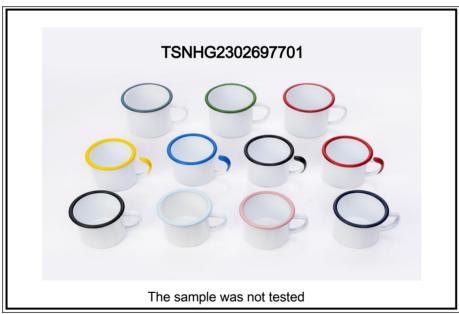
Sample photo:

SN1 TSN23-026977.001 white cup with dark blue rim (claimed by the client)

ENAMEL
